FHWA/IN/JTRP-98/15

Final Report

METHODS OF CORROSION PROTECTION AND DURABILITY OF CONCRETE BRIDGE DECKS REINFORCED WITH EPOXY-COATED BARS – PHASE I

March 23, 1999

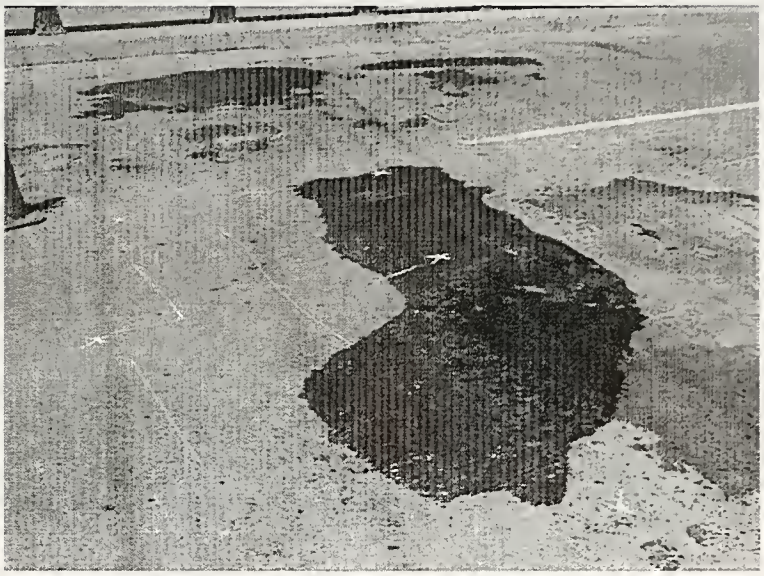
Figure 4.5 Delaminations Detected and Marked after Chain Drag

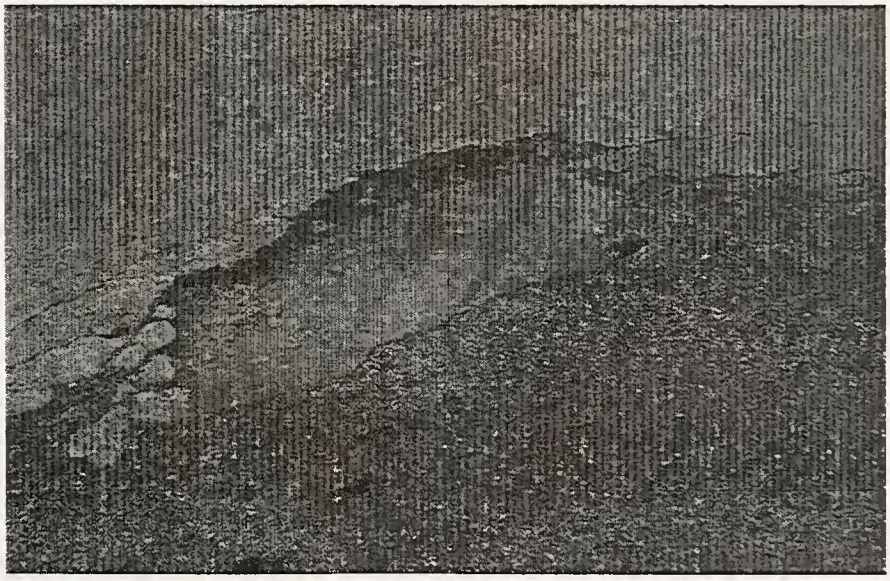
Figure 4.6 Spall with Reinforcement Exposed

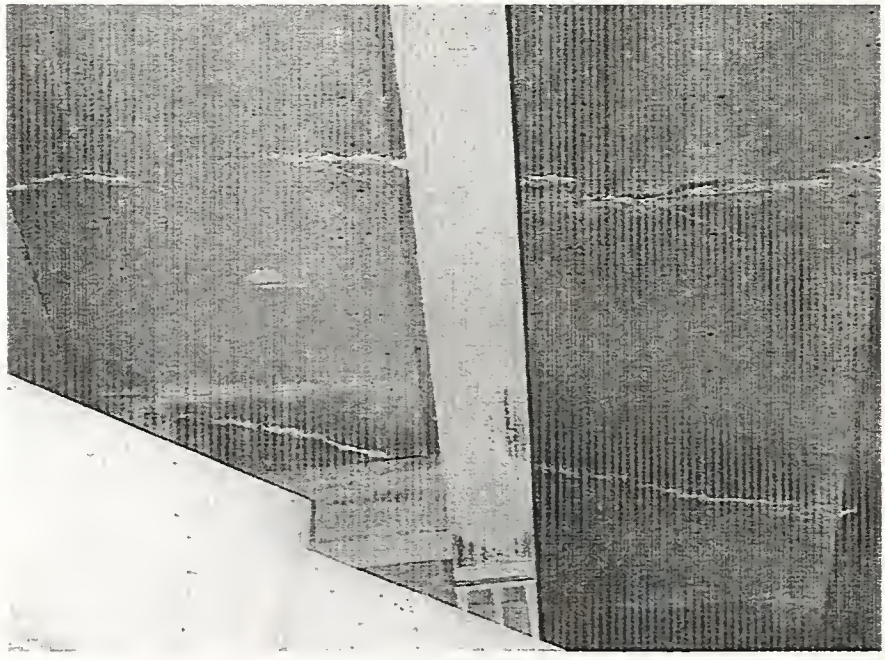
Figure 4.12 Cracking seen on Underside of Bridge Deck (Structure #37-47-5980)

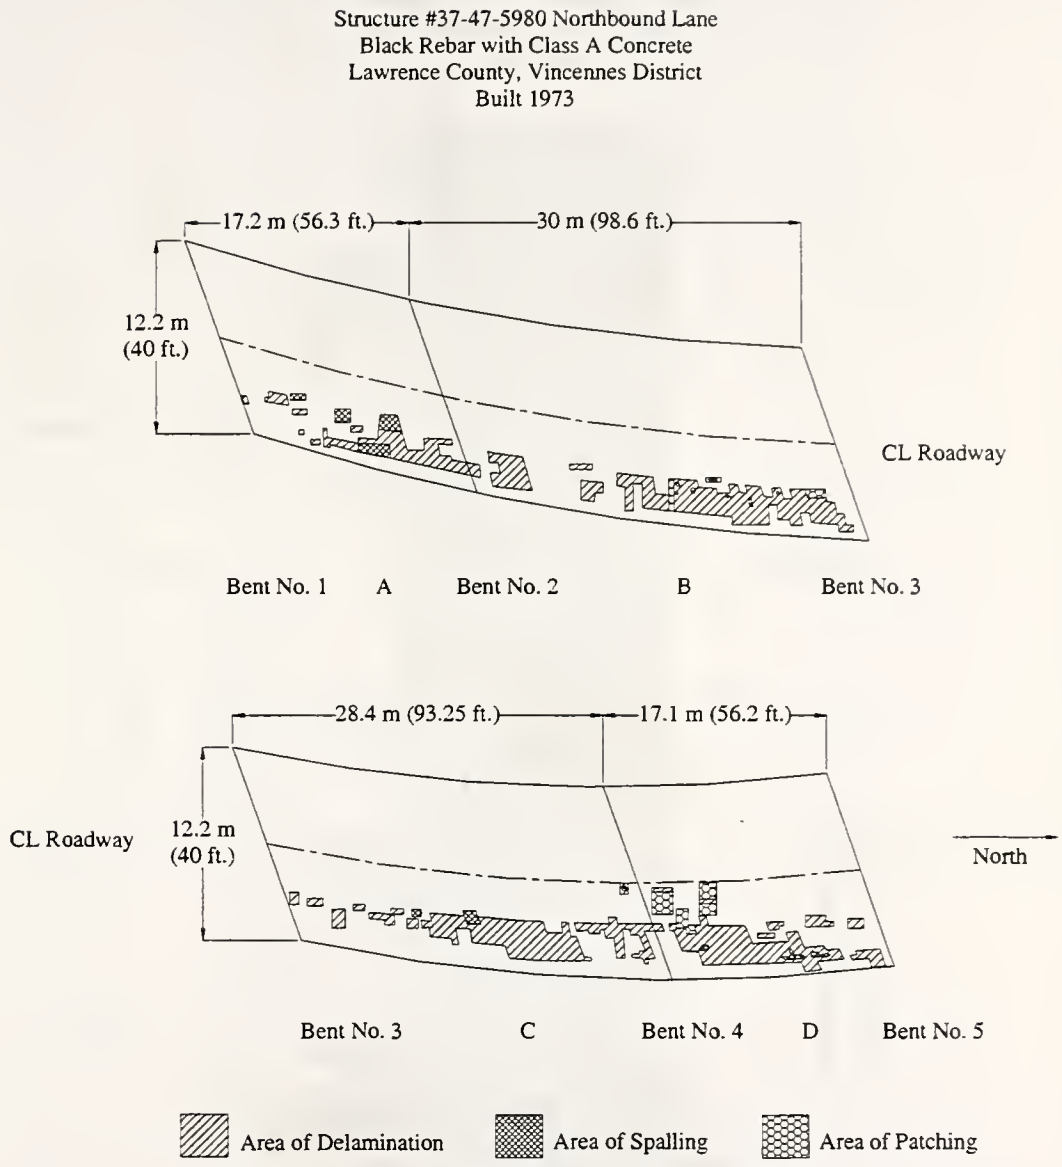
Figure 4.13 Delaminations, Spalls, and Patching Found on Structure #37-47-5980

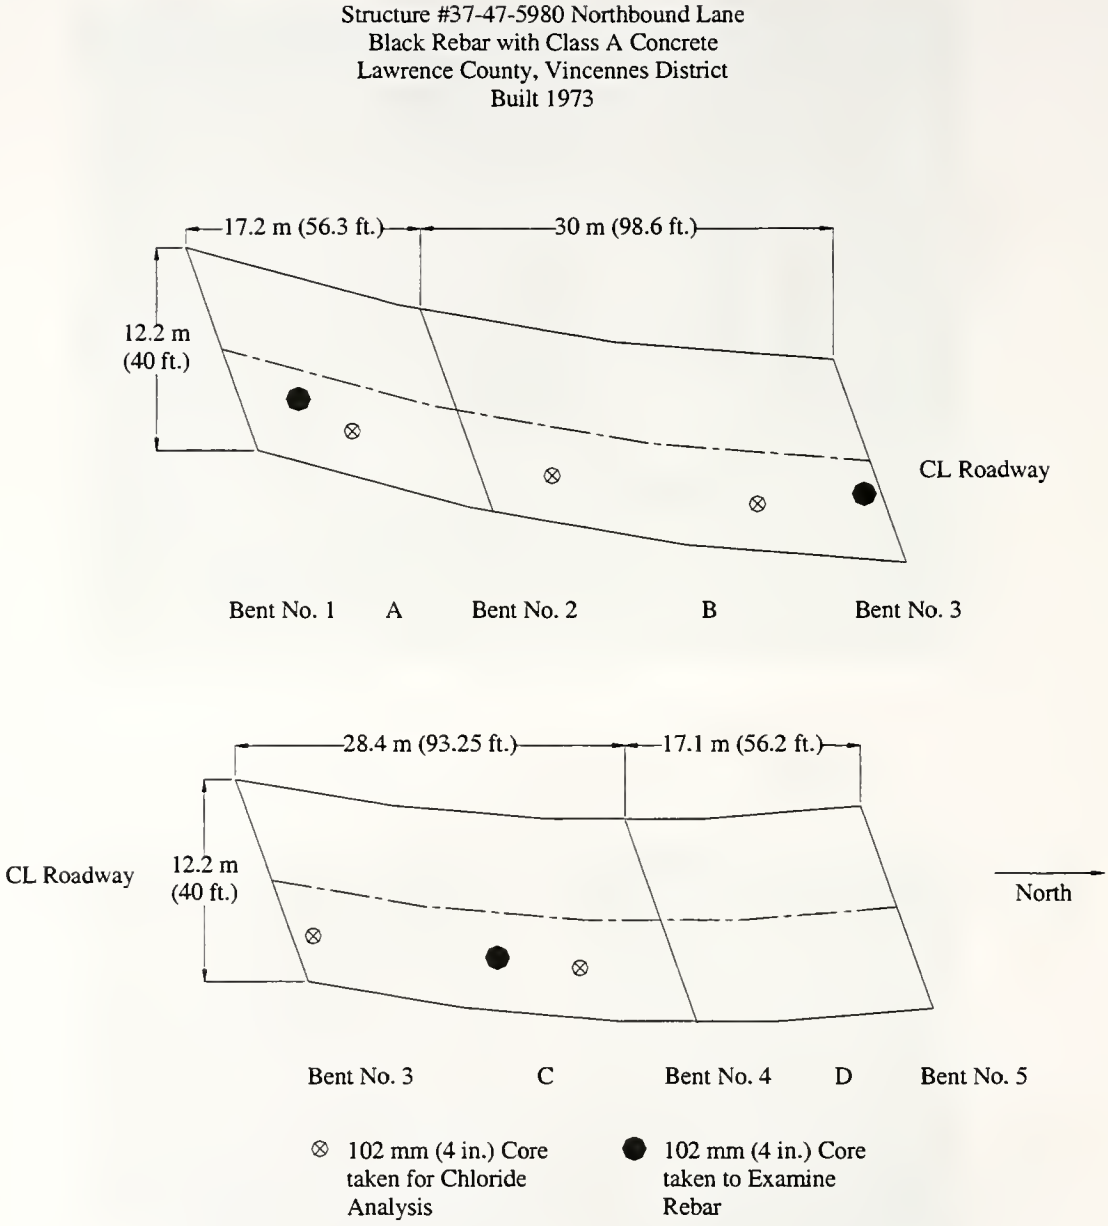
Figure 4.14 Location of Cores Taken From Structure #37-47-5980

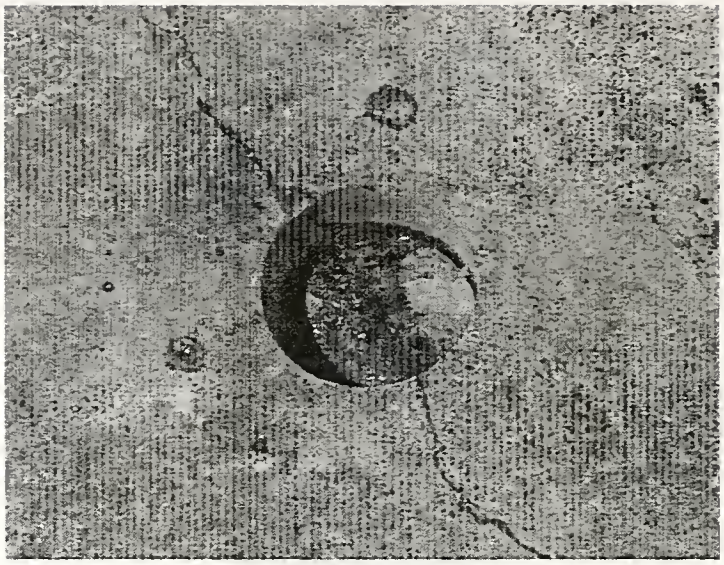
Figure 4.16 Core Taken in Cracked Region (Structure #37-47-5980)

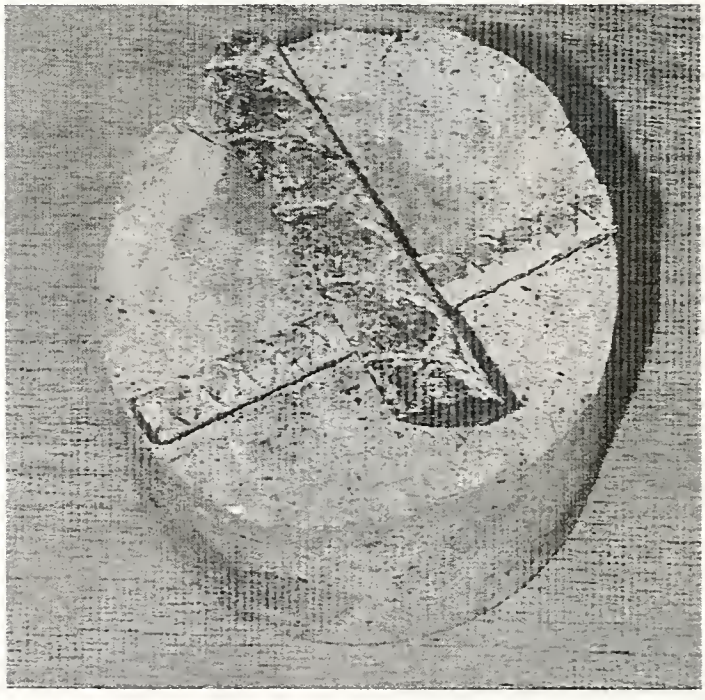
Figure 4.17 Reinforcement from Core Taken in Sound Area of Deck (Str. #37-47-5980)

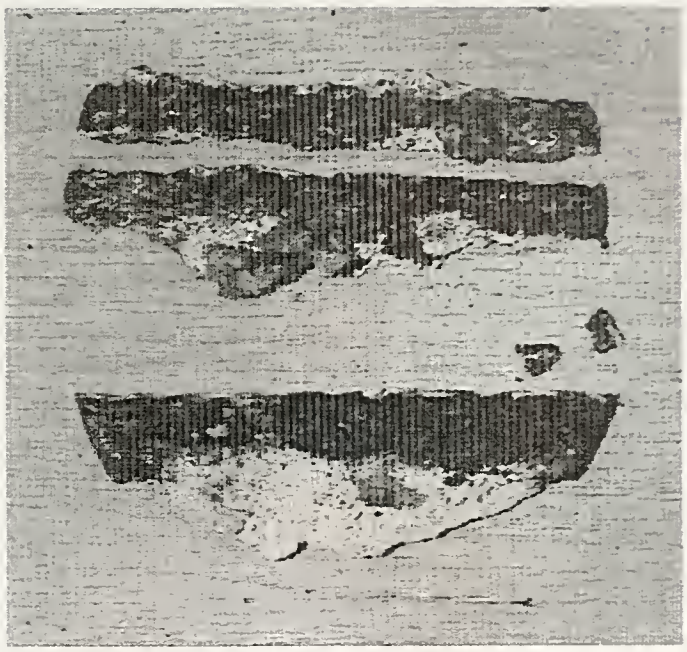
Figure 4.18 Reinforcement Removed in Delaminated Area of Deck (Str. #37-47-5980)

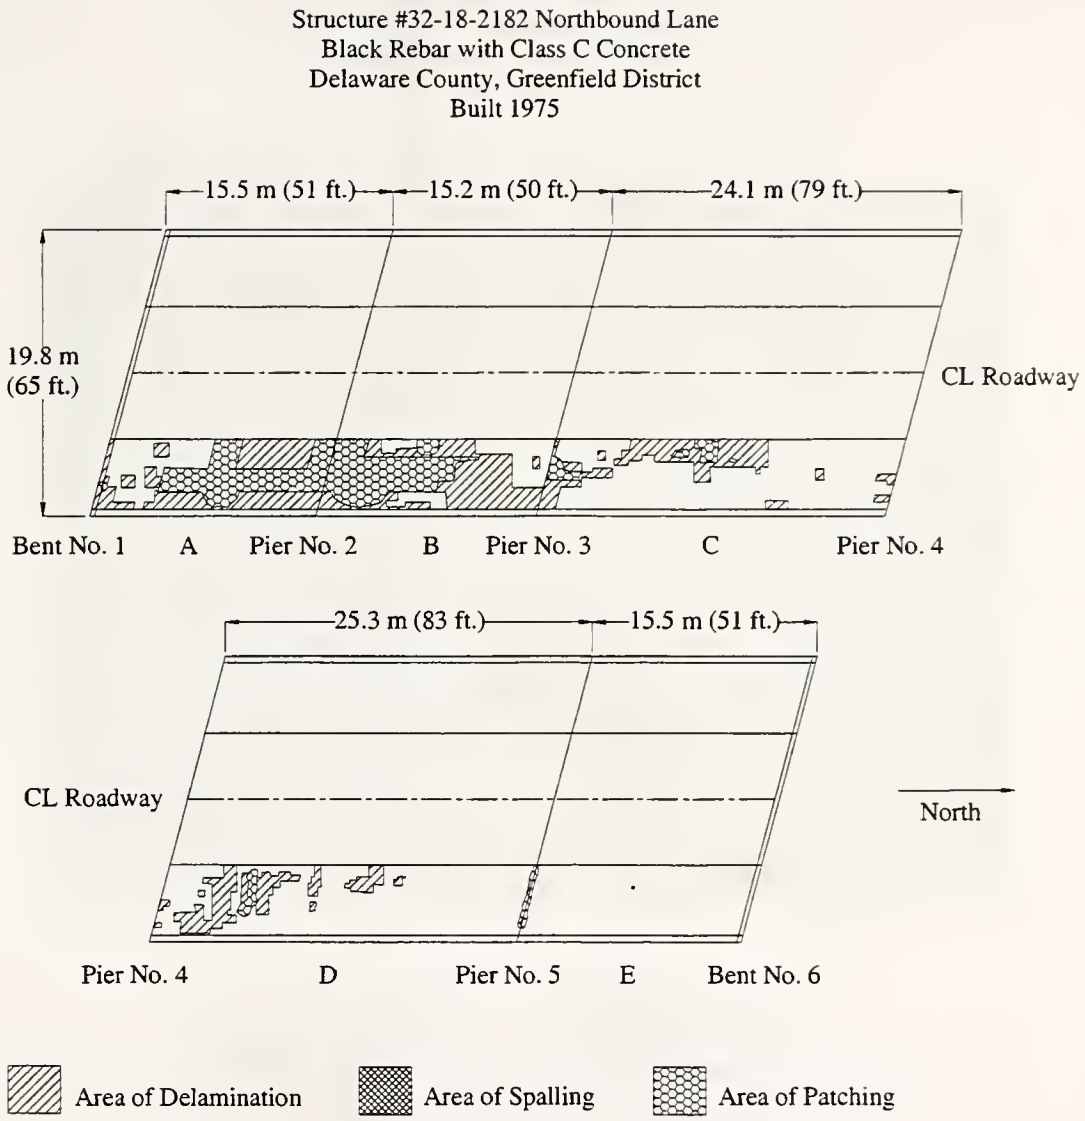
Figure 4.20 Delaminations, Spalls, and Patching Found on Structure #32-18-2182

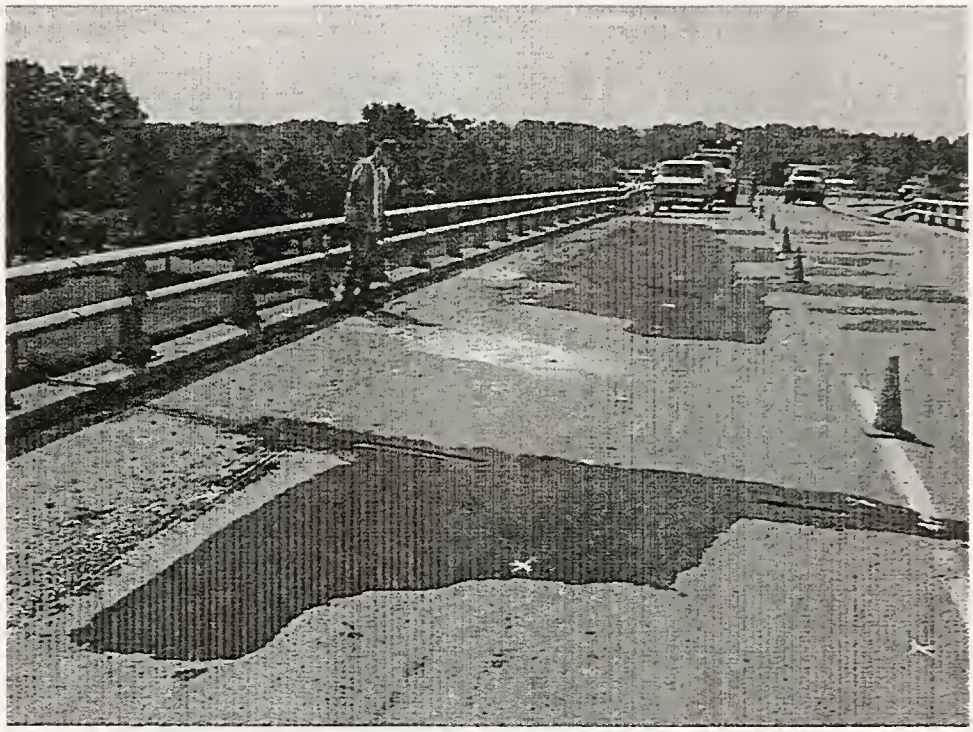
Figure 4.22 Extensive Patching on Bridge Deck (Structure #32-18-2182)

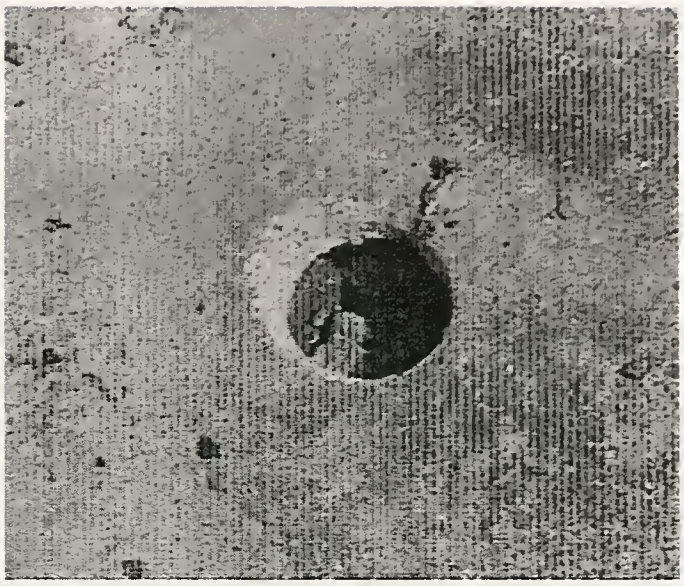
Figure 4.24 Delamination Present in the Bridge Deck (Structure #32-18-2182)

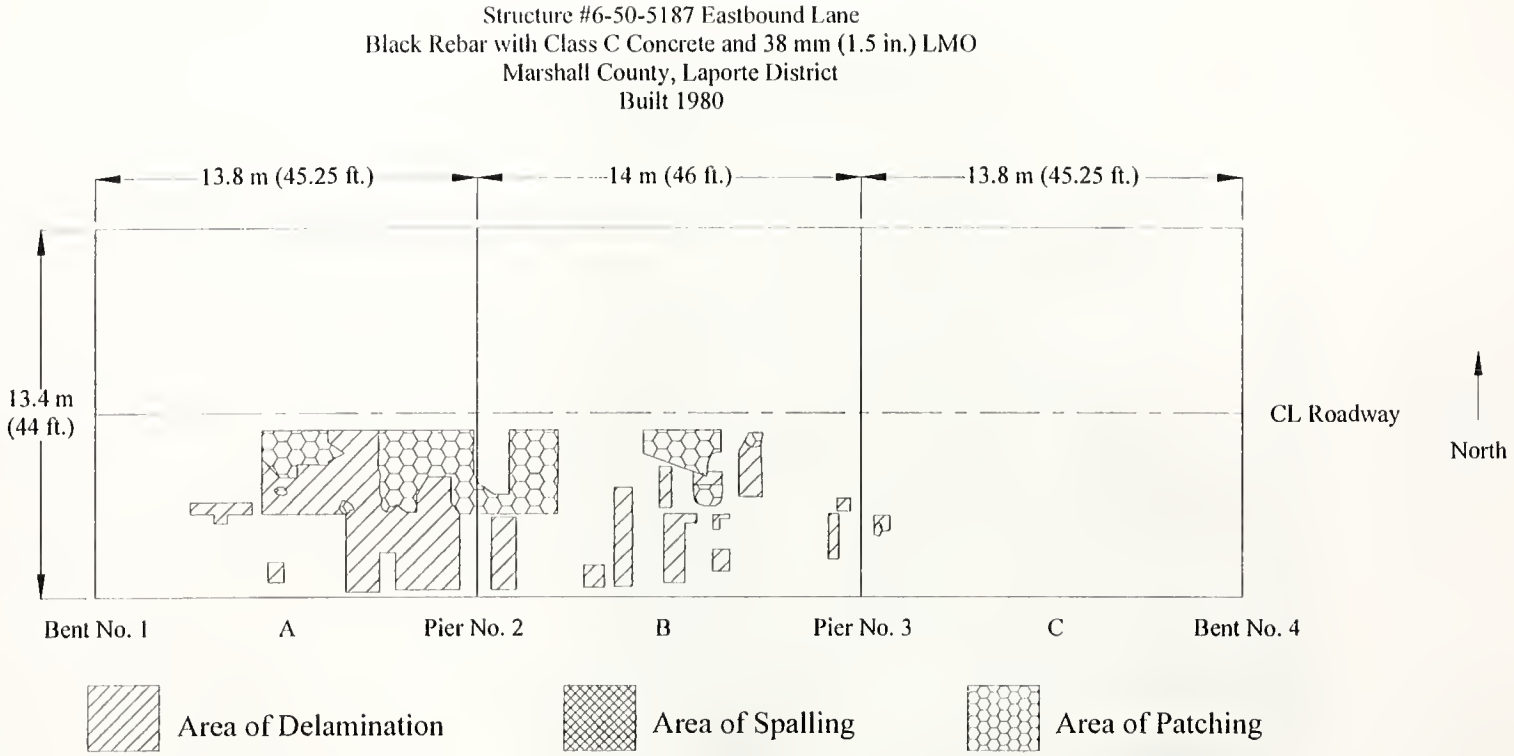
Figure 4.28 Delaminations, Spalls, and Patching Found on Structure #6-50-5187

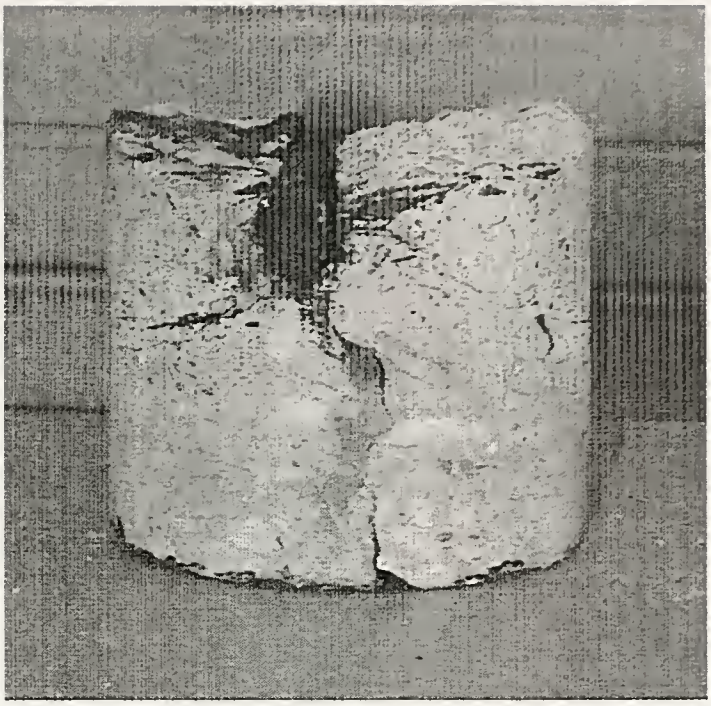
Figure 4.31 Core Taken in Cracked Area (Structure #6-50-5187)

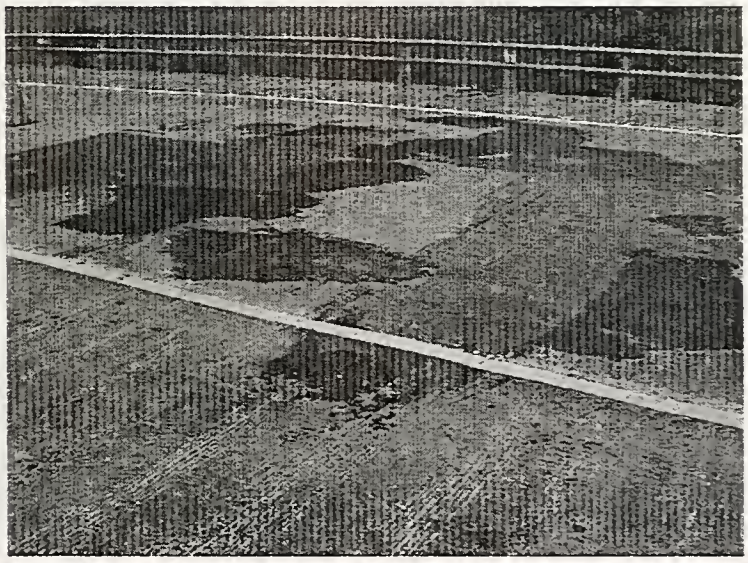
Figure 4.32 Extensive Patching of Bridge Deck (Structure #6-50-5187)

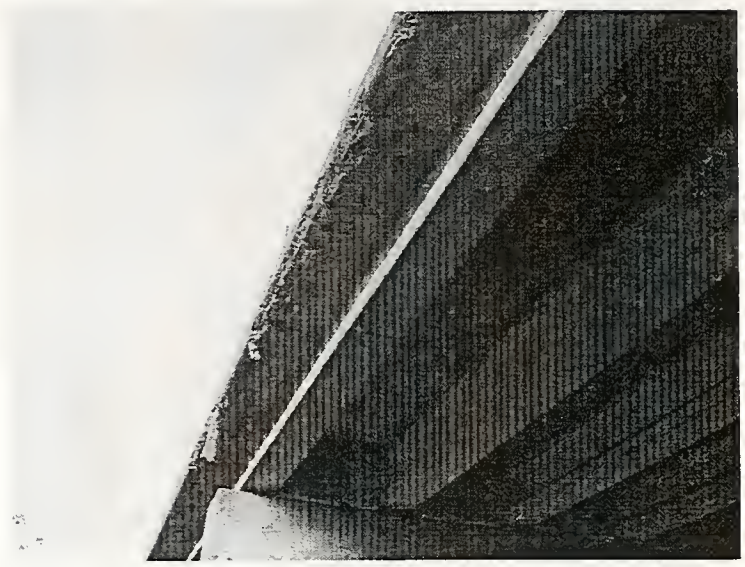
Figure 4.33 Corrosion Damage to Underside of Deck (Structure #6-50-5187)

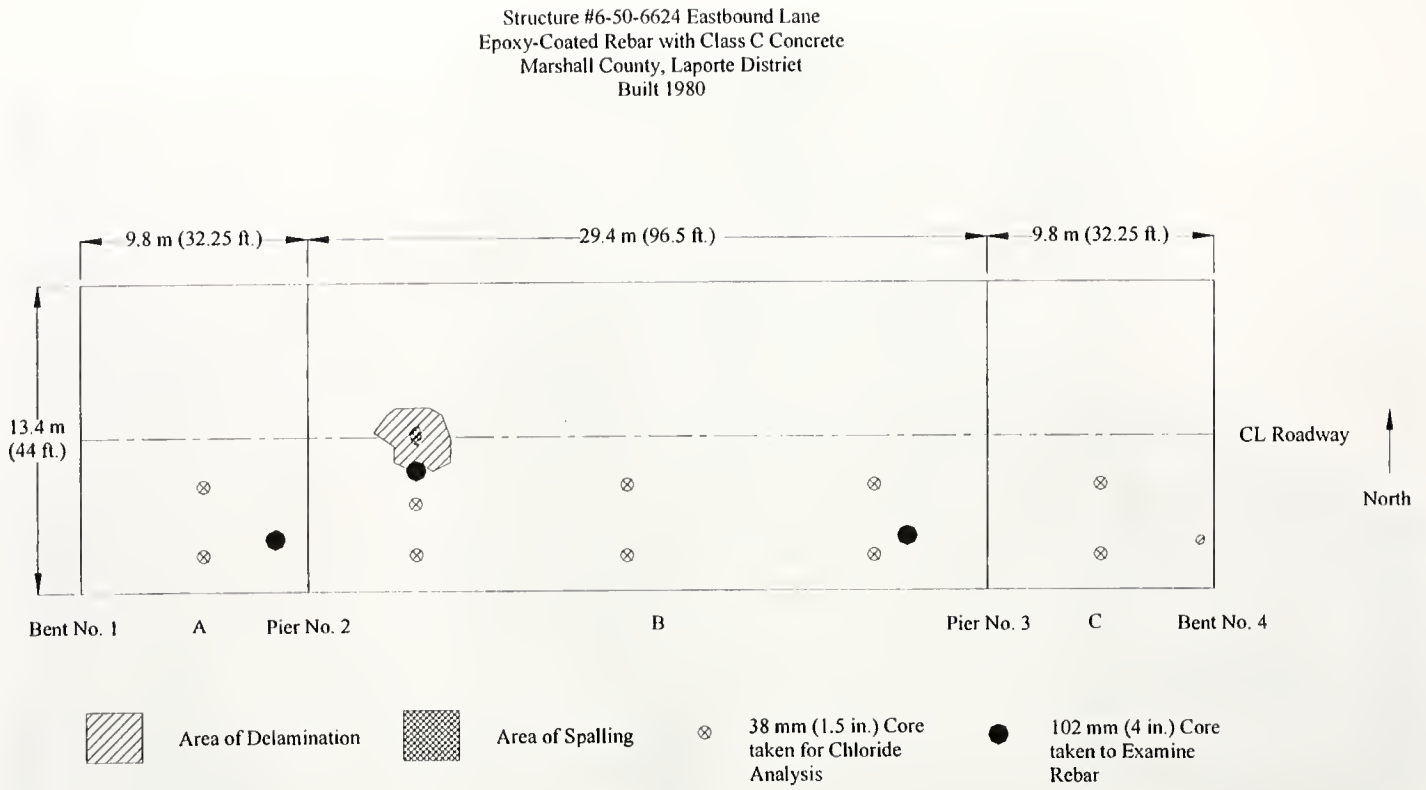
Figure 4.36 Delaminations, Spalls, and Location of Cores for Structure #6-50-6624

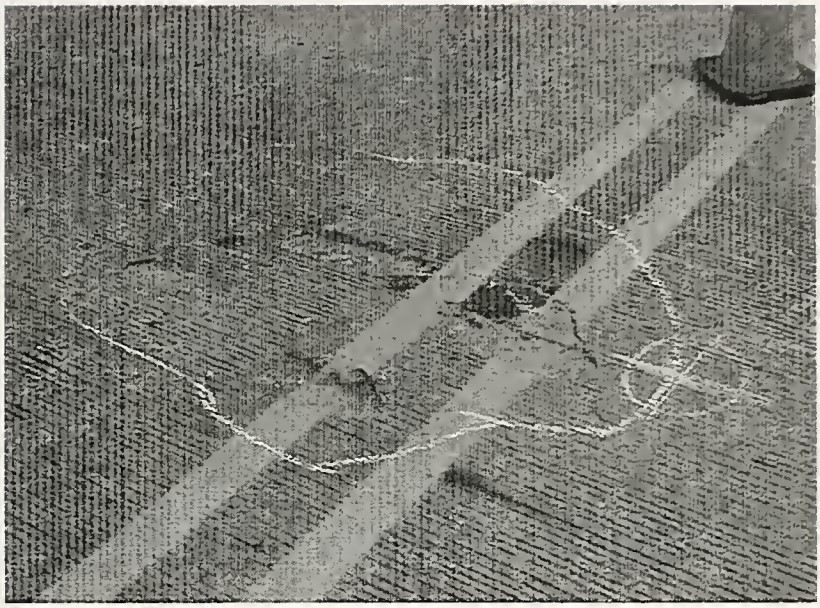
Figure 4.37 Delaminated Area with Spalls and Exposed Reinforcement
(Structure # 6-50-6624)

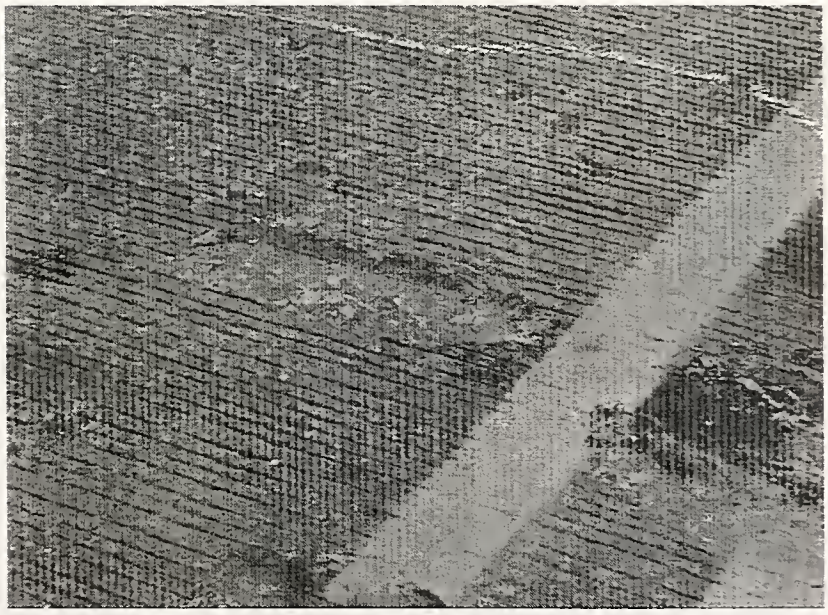
Figure 4.38 Exposed Rebar with Epoxy Coating Removed (Structure #6-50-6624)

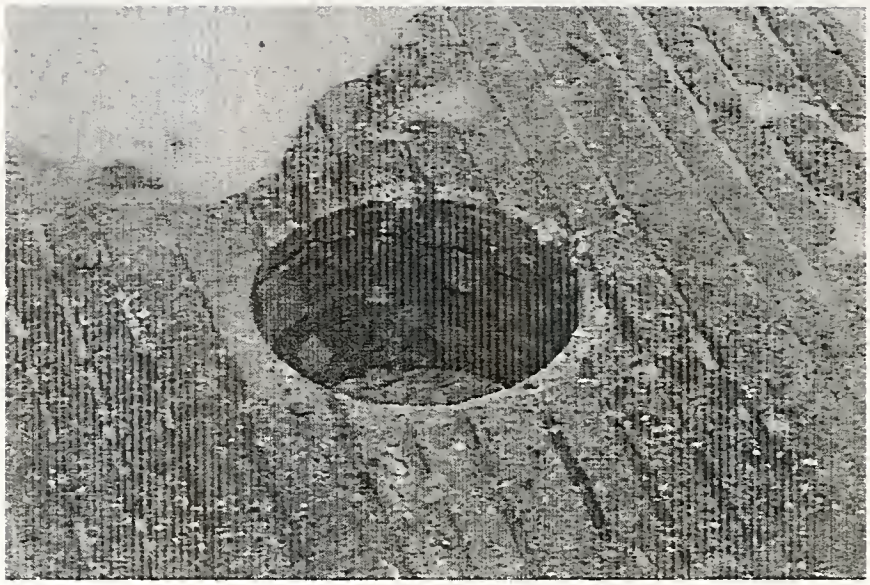
Figure 4.39 Delamination from Corrosion of Rebar (Structure #6-50-6624)

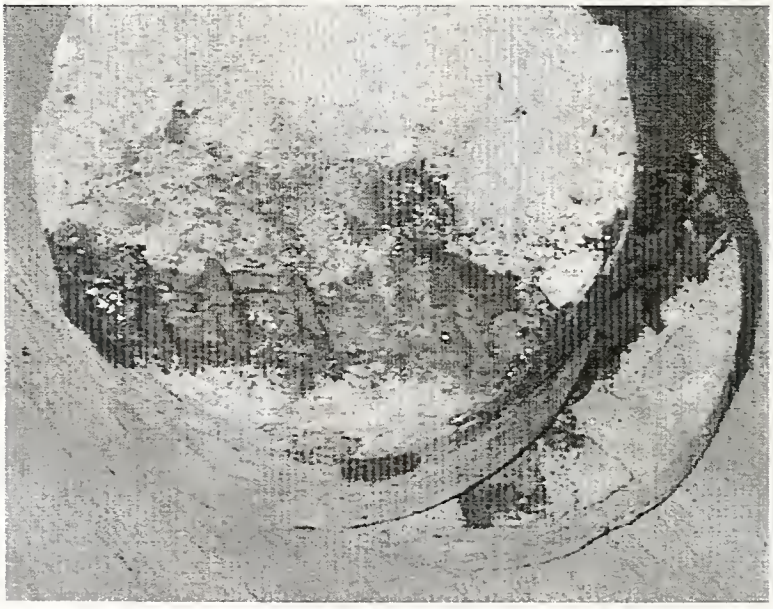
Figure 4.40 Core Removed from Delaminated Area of Deck (Structure #6-50-6624)

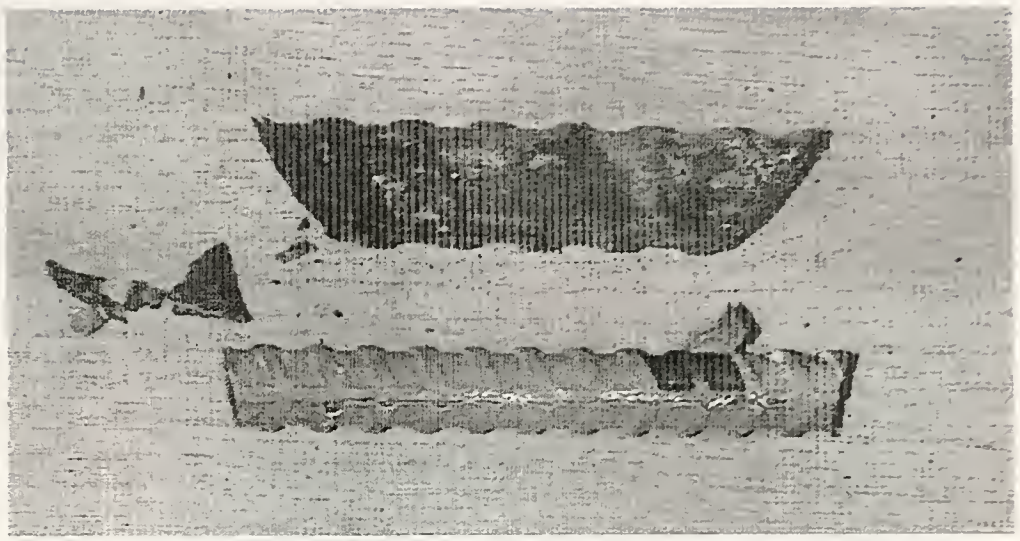
Figure 4.41 Rebars Removed from Core Taken in Delaminated Area
(Structure #6-50-6624)

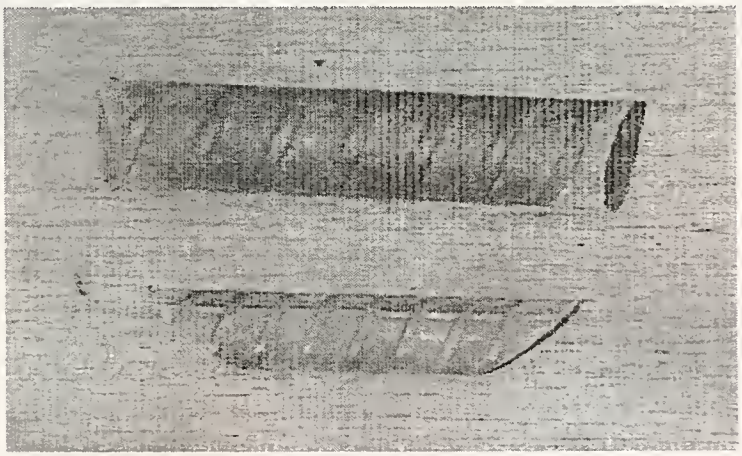
Figure 4.42 Discoloration of Rebar Removed from Sound Area of Deck
(Structure #6-50-6624)

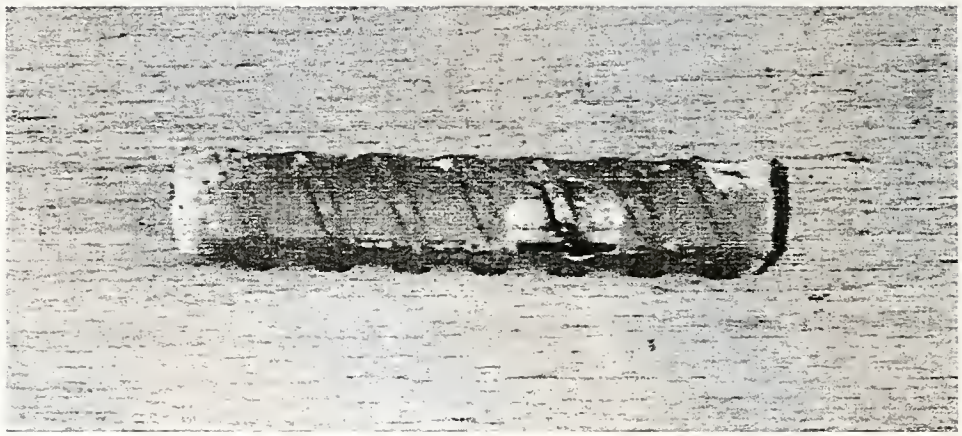
Figure 4.43 Rebar with Coating Easily Removed with Knife (Structure #6-50-6624)

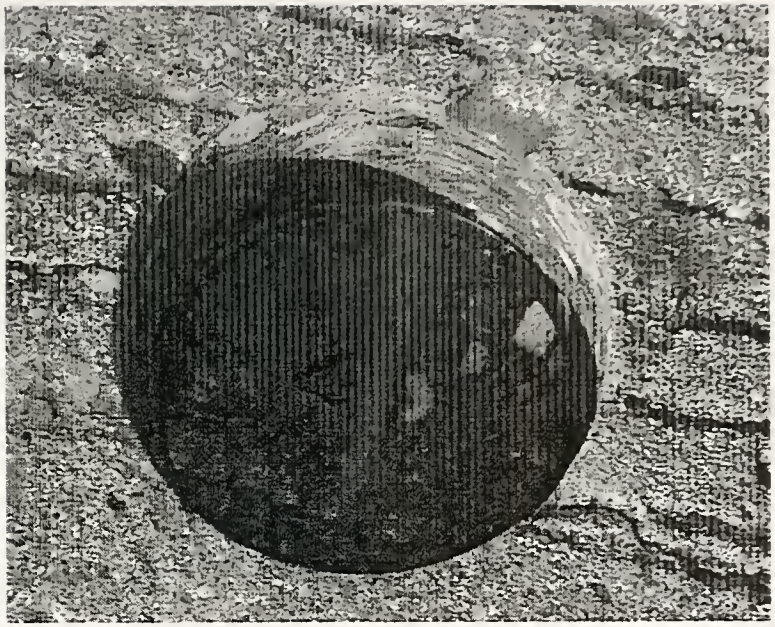
Figure 4.46 Core Taken in Cracked Location (Structure #331-50-6608)

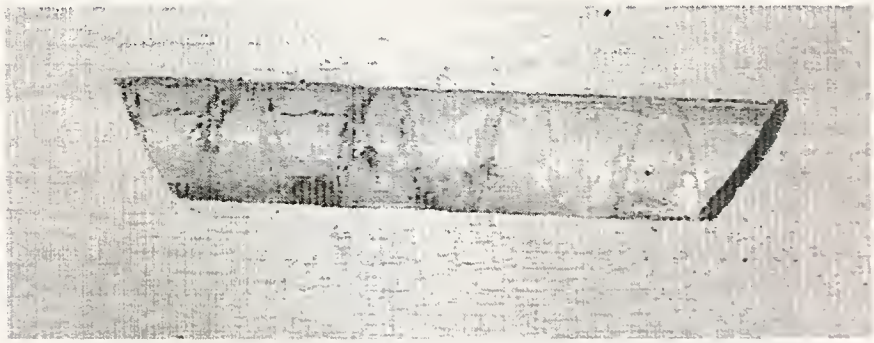
Figure 4.47 Rebar Removed from Cracked Location in Deck (Structure #331-50-6608)

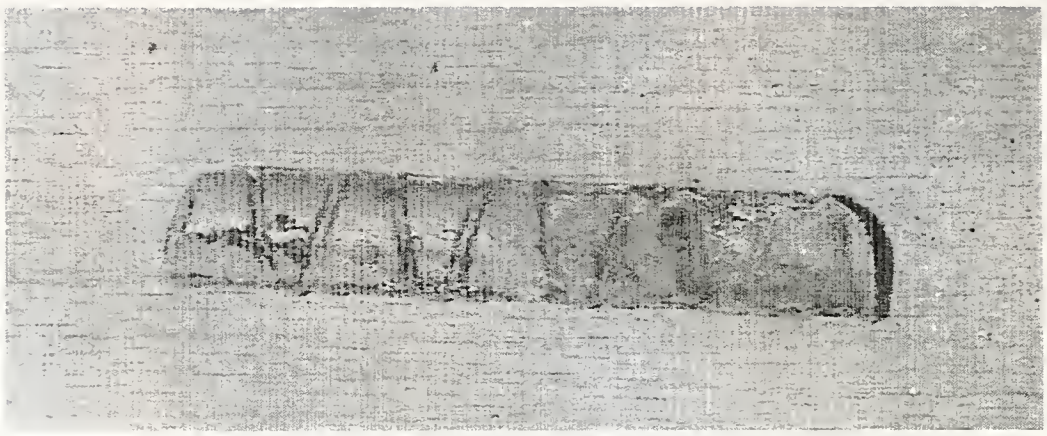
Figure 4.48 Alternate Side of Rebar Removed from Cracked Area
(Structure #331-50-6608)

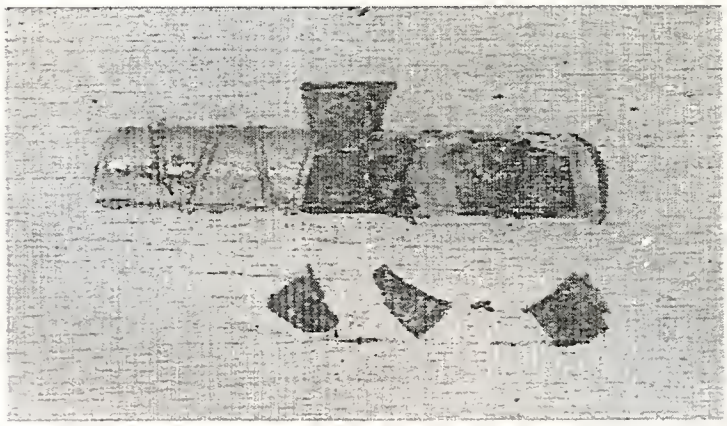
Figure 4.49 Underfilm Corrosion Found after Removing Coating
(Structure #331-50-6608)

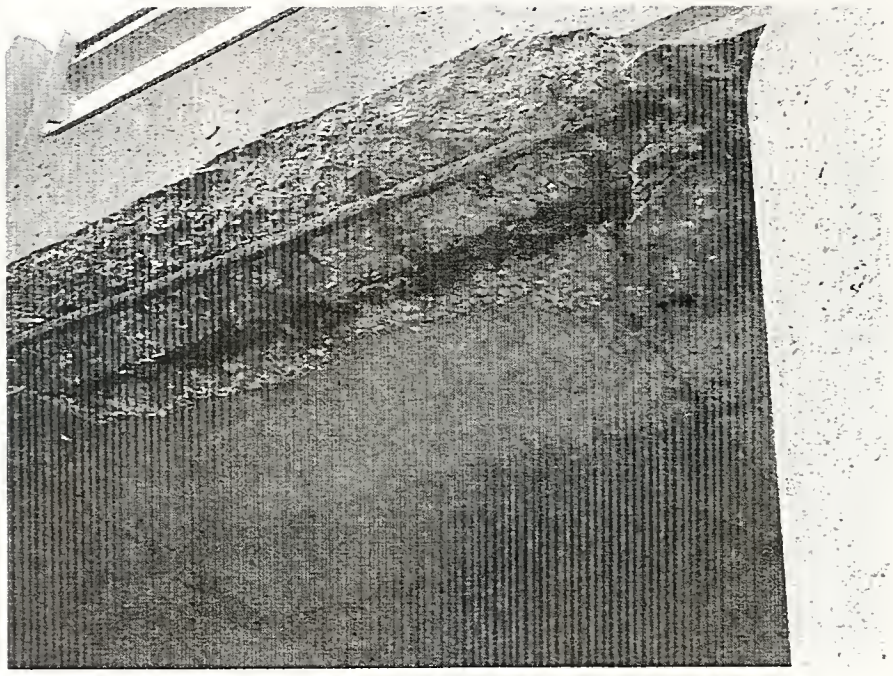
Figure 4.53 Concrete Spalling on Underside of Deck (Structure #6-50-6577)

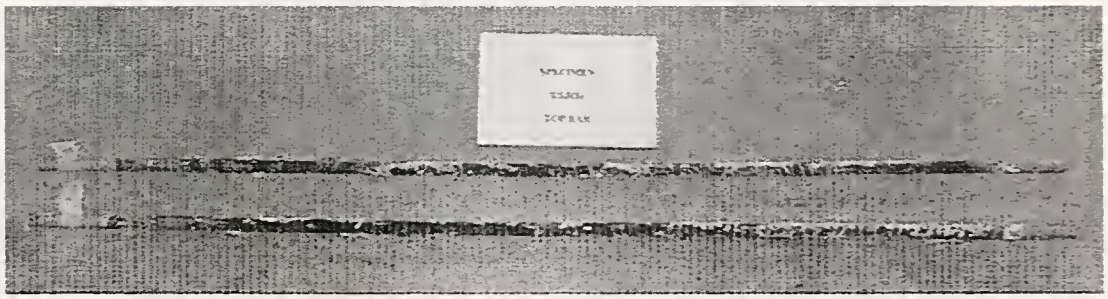
The specimens containing uncoated reinforcement showed uniform corrosion of the top bars. Figure 5.20 shows the top bars from specimen U1.0(b). Uniform corrosion over the entire length of the bar with minor loss of cross-sectional area had occurred. As shown in Figure 5.21 none of the bottom bars of the specimens had any corrosion. The top bars from specimen U2.5(b) are shown in Figure 5.22. The uniform corrosion of these bars was not as extensive as the bars extracted from specimen U1.0(b) and the corrosion was limited to the inner two feet of the length of the bar. No loss of cross-sectional area was observed in these bars.

Figure 5.20 Top Bars from Specimen U1.0(b) at Week 64

Figure 5.21 Bottom Bar from Specimen U1.0(b) at Week 64

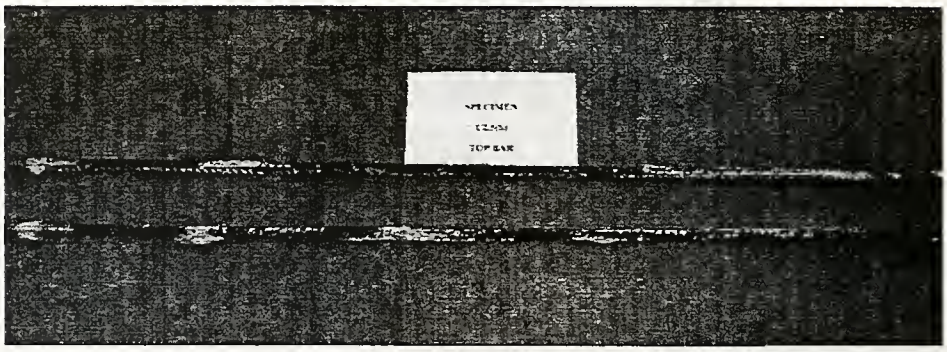
Figure 5.22 Top Bars from Specimen U2.5(b) at Week 64

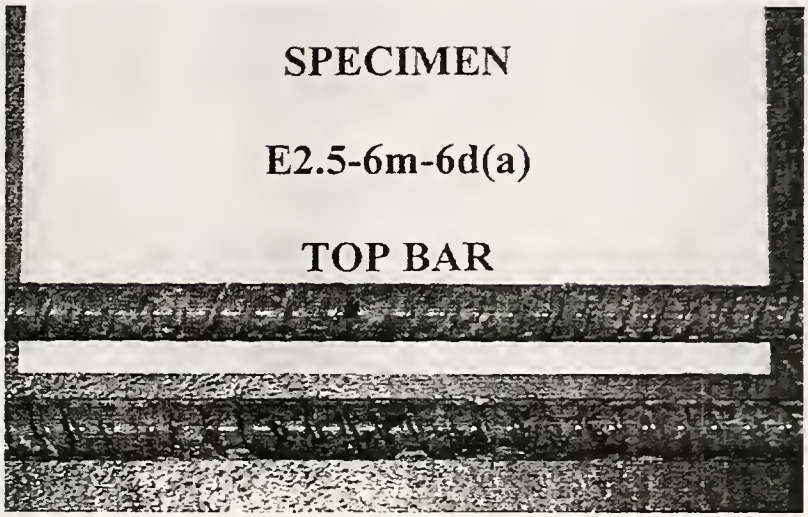
Inspection of the top bars removed from the specimens containing epoxy-coated reinforcement found only minor corrosion with no loss in cross-sectional area. In all cases the epoxy coating was well adhered and difficult to remove in areas away from rusting. No corrosion was found under the coating in areas away from the rusted areas. Figures 5.23 through 5.28 show the condition of the bars removed from the specimens containing epoxy-coated bars. The findings from each specimen are presented below.

Figure 5.23 Top Bars from Specimen E2.5-6m-6d(a) at Week 64

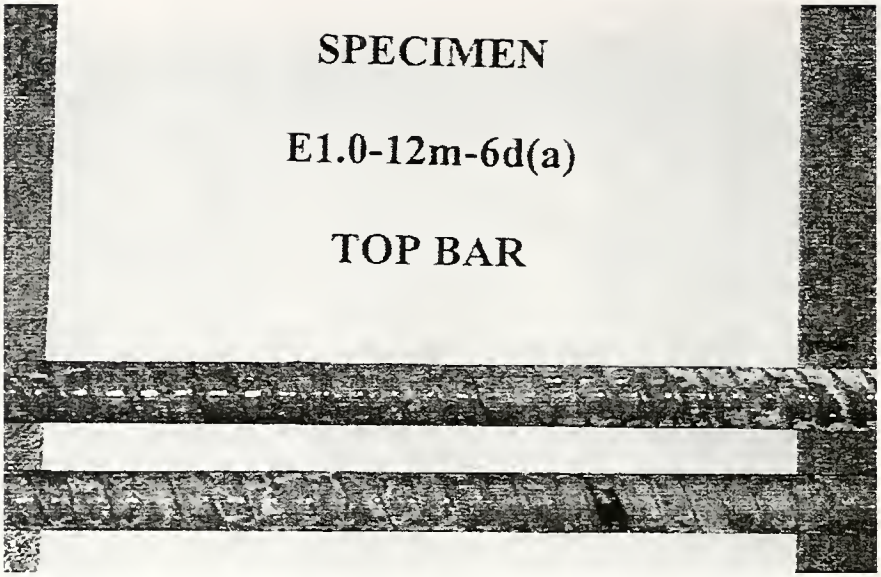
Figure 5.25 Top Bars from Specimen E1.0-12m-6d(a) at Week 64

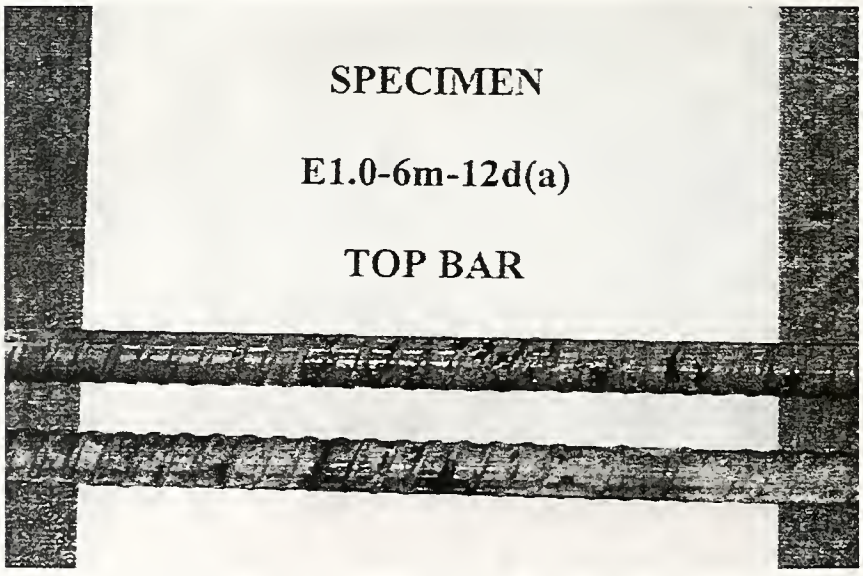
Figure 5.26 Top Bars from Specimen E1.0-6m-12d(a) at Week 64

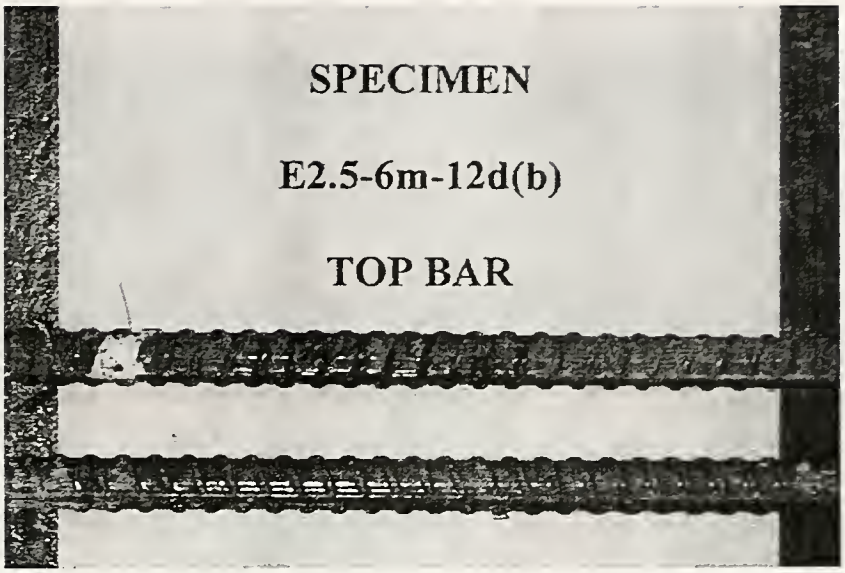
Figure 5.27 Top Bars from Specimen E2.5-6m-12d(b) at Week 64

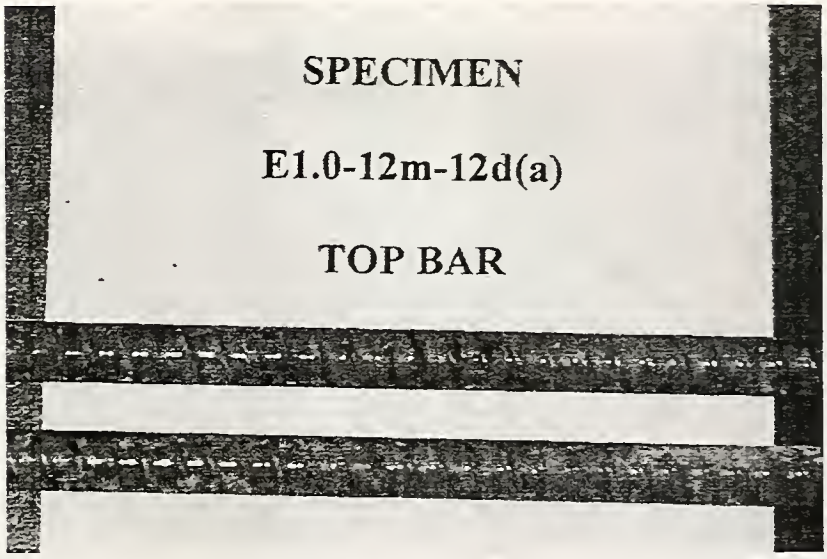
Figure 5.28 Top Bars from Specimen E1.0-12m-12d(a) at Week 64

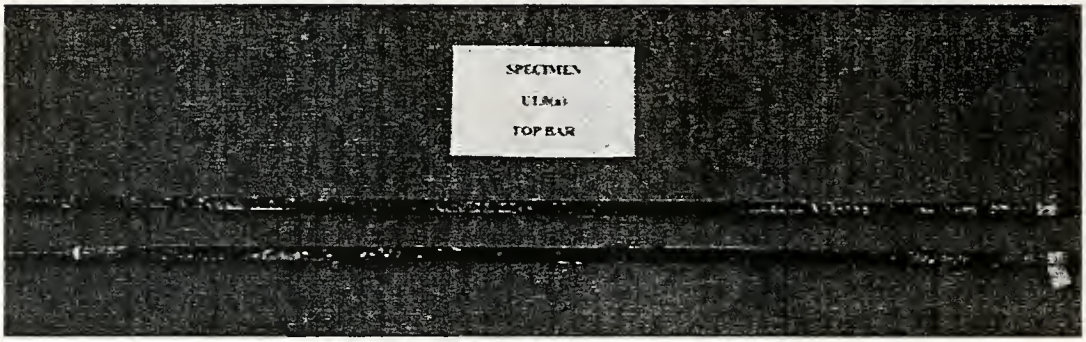
The specimens containing uncoated reinforcement showed uniform corrosion of the top bars. Figure 5.29 shows the top bars from specimen U1.0(a). Uniform corrosion over the entire length of the bar with small loss of cross-sectional area was observed. The top bars from specimen U2.5(a) are shown in Figure 5.30. Light corrosion along the length of one of the top bars was observed. The second bar had minor rusting along a 152.4 mm (6 in.) length of bar. No loss of cross-sectional area was observed in these bars.

Figure 5.29 Top Bars from Specimen U1.0(a) at Week 77

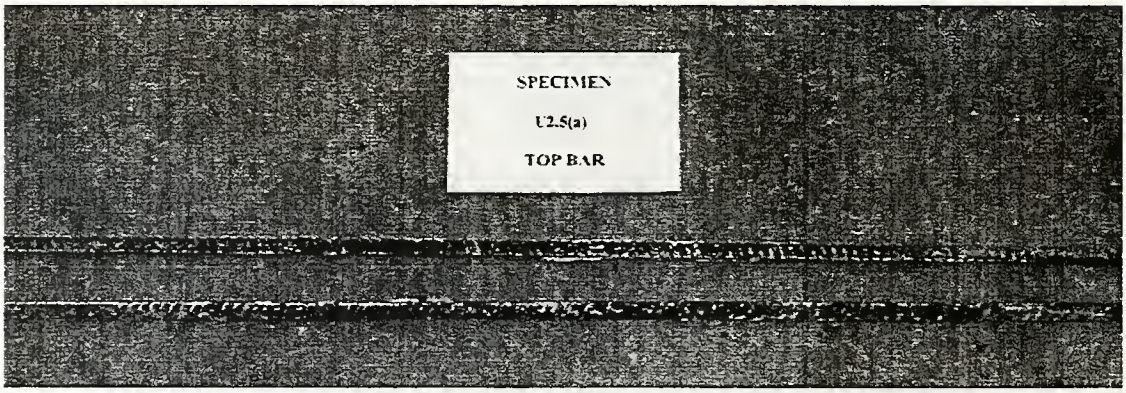
Figure 5.30 Top Bars from Specimen U2.5(a) at Week 77

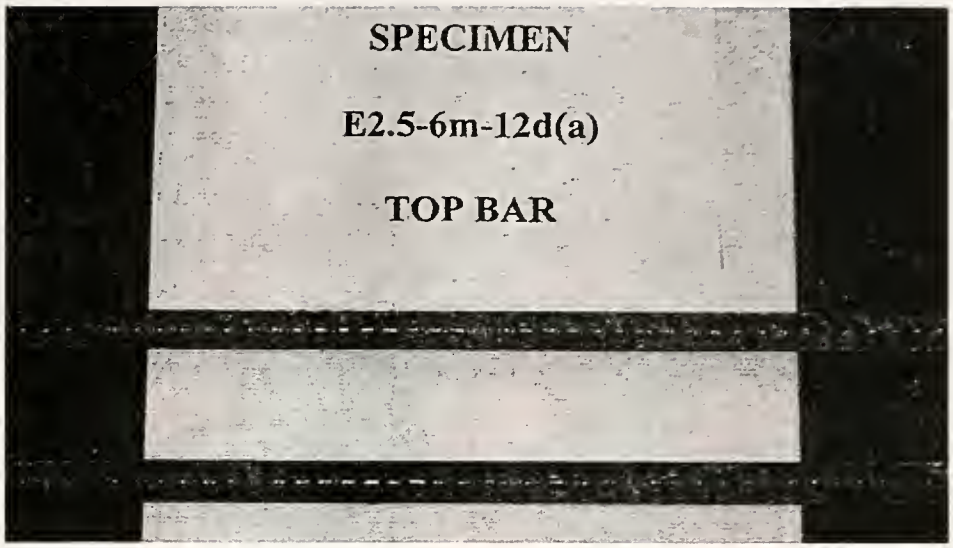
Inspection of the top bars removed from the specimens containing epoxy-coated reinforcement found only minor corrosion with no loss in cross-sectional area. In all cases the epoxy coating was well adhered and difficult to remove in areas away from rusting. No corrosion was found under the coating in areas away from the rusted areas. Figures 5.31 through 5.36 show the condition of the bars removed from the specimens containing epoxy-coated bars. The findings from each specimen are presented below.

Figure 5.35 Top Bars from Specimen E2.5-6m-12d(a) at Week 77

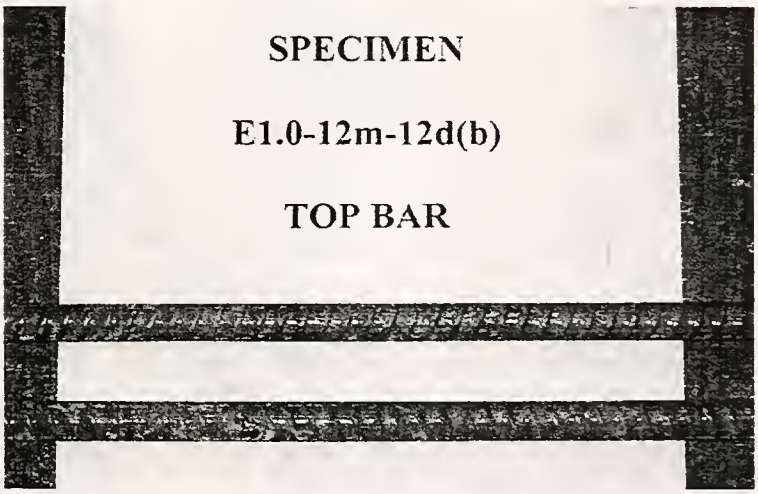
Figure 5.36 Top Bars from Specimen E1.0-12m-12d(b) at Week 77
